Weathering and decay

Breakdown rates of rock carvings in the southern part of Sweden

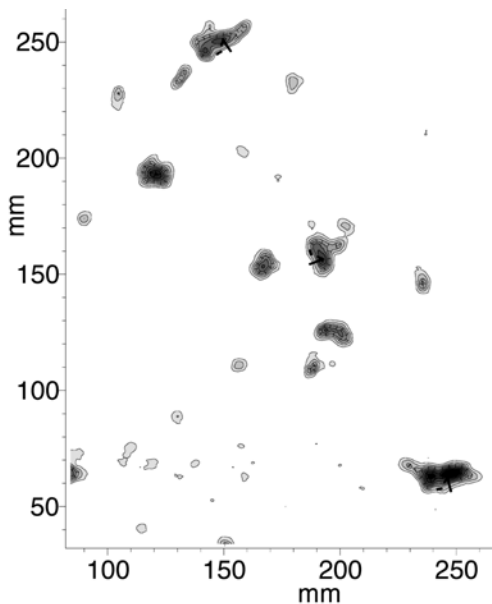
Fig. 3. Surface lowering to depths of more than 0.5 mm at Jörlov in the parish of Skee (site 15) between 1995 and 2002. The contour interval is 0.25 mm. The downwearing mainly proceeds by detachment of thin rock fragments of a few cm in size. The rates have been similar throughout the entire period.

At Tanum 12 (Aspeberget, site 16) and at Skee 619 (Jörlov, site 15) the breakdown is much more severe. At these sites granular disintegration also plays an important part in the breakdown but there is also some kind of "micro exfoliation". Flakes about one mm thick and around one cm in size weather away, leaving whitish scars that are easily recognised macroscopically. When a flake has disappeared from one place, the weathering usually continues at another place. At Skee 619 the measured rock carving figure is hardly recognisable any more. Places where material losses have taken place here between 1995 and 2002 are shown in

figure 3. During the beginning of the monitoring period, until 1995 a shelter covered the measured sites at Aspeberget. It was built in order to protect the rock carvings from weathering, but its effect was doubtful. Trickle water could still flow across the panel and organic material could be accumulated. In 1996 the shelter was dismantled and since then the area is temporarily covered during winter seasons, to minimise frost weathering. Drainage water from vegetated areas above the locality is also prevented from trickling over the rock carvings. Almost all indicated decay at Tanum 12 (I) took place between 1994 and 1996, while material losses were minimal during the rest of the monitoring period. Tanum 12 (II & III) are situated in the immediate vicinity but have no rock carving figures. At these two sites the first measurements were made 1996 and the last 2002. Calculated downwearing rates during this period are almost zero. It is difficult to tell whether the winter covering caused the downwearing to decrease or if it is due to natural variations in the strength of weathering processes during different time intervals. On an obviously already weathered rock surface it might well be that the covering really prevents rock fragments from being detached and material losses being caused. Signs of ongoing "micro exfoliation" are, however, still seen adjacent to the three laser scanned areas.

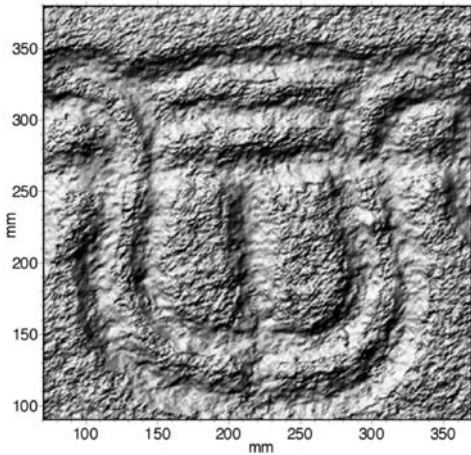
A digital shadow image of a rock carving in coarse-grained granite at Frännarp in the parish of Gryt in the northern part of the province of Skåne (site 4) is shown in figure 4. The downwearing is fairly small and varies from 0.21 to 0.42 mm in 1 000 years depending on the period over which the calculations were made. Almost all material loss occurred between 1998 and 2002. It mainly proceeds by granular disintegration. The rock carving of a network figure at Borg (Herrebro), near the town Norrköping (site 20) lies only twenty m away from a motorway. The rock is grey, fine-grained granite. Although the indicated downwearing rates in table 1 cannot be considered as disastrous, the site is at great risk. This is mainly due to salt weathering that is considered to be ef-

Fig. 4. Digital shadow image of a carriage made in coarse-grained granite at Frännarp in the parish of Gryt, province of Skåne (site 4). The imaginary light comes from the Northwest.

fective in causing rock breakdown (Kwaad, 1970 and Goudie et al., 1970). When the motorway is salted during winter, to prevent skidding, salt spray is spread over the outcrop by passing cars.

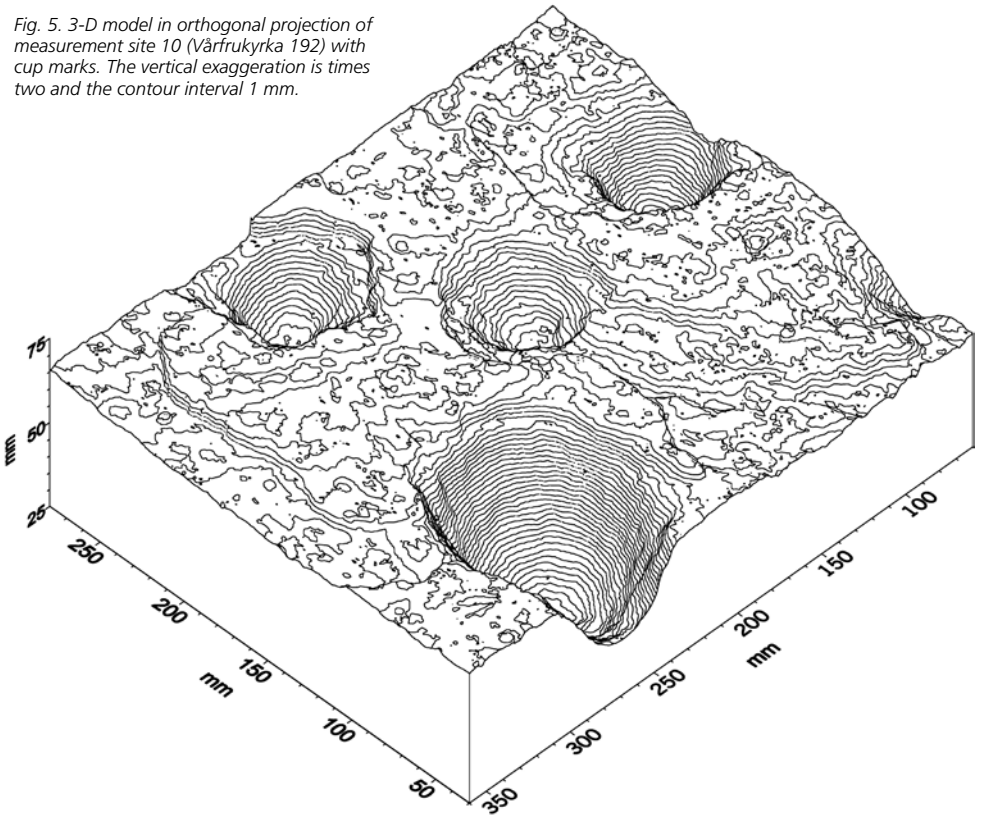
present mainly by granular disintegration although the rock types are contrasting. At Vårfrukyrka 192 the rock is of Svekofennian supracrustal origin and can be described as gneissic mica schist. The measurements were made over a number of cup marks (figure 5) and the calculated downwearing amounted to 12.98 mm in 1 000 years between 1994 and 1996. The result is somewhat inconclusive since it was difficult to get a good overlap between measurements from consecutive occasions, but it is clear that decay is fast. It could be that such features as cup marks are preserved for a long time even at places with rapid rock breakdown. There is a possibility that they weather, and deepen faster than the surrounding surfaces are lowered. If other rock carvings have ever been present at this site they would already have disappeared due to the intense weathering. The grey, veined gneiss at Foss 6, with a calculated downwearing rate of 3.73 mm in 1 000 years between 1996 and 2002, has a soft and porous surface and the lichen growth on the rock carvings is extensive. The figures on the panel are often cut to a depth of more than one cm but their contours are not very distinct due to the severe recent decay. When the character of the rock with its surface alteration is taken into consideration it can be expected that the lifetime of the rock carvings at Foss 6 is limited.

Fig. 5. 3-D model in orthogonal projection of measurement site 10 (Vårfrukyrka 192) with cup marks. The vertical exaggeration is times two and the contour interval 1 mm.

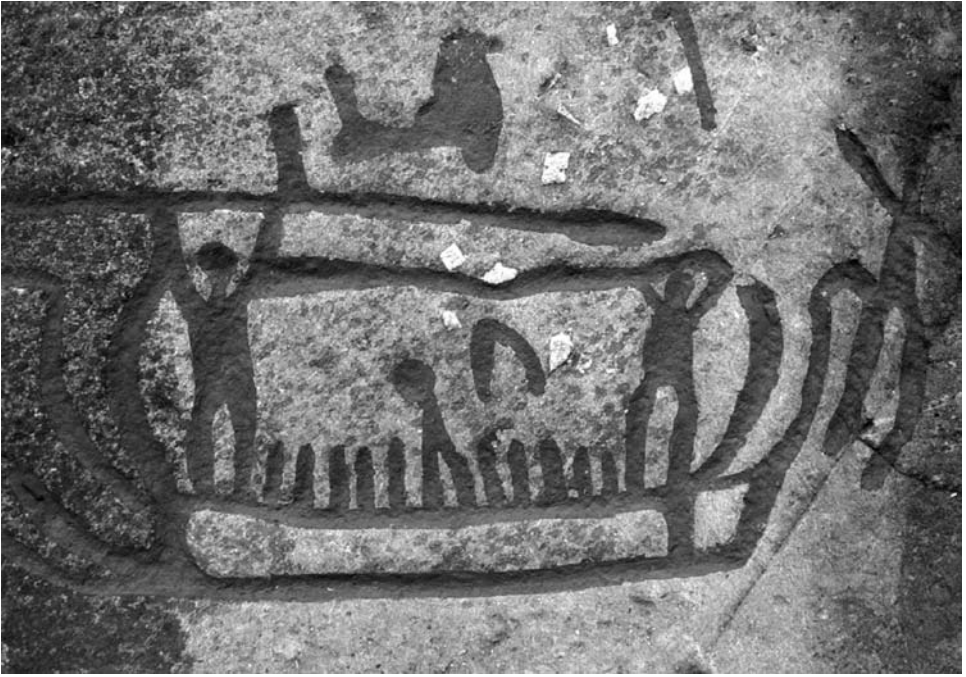
Fig. 6. Photograph of the micro mapped rock carving at Fiskeby in the parish of Östra Eneby, Norrköping (site 24). The measured area includes the man with a spear in the right part of the ship. The protruding andalusite crystals are a characteristic of the rock at this place.

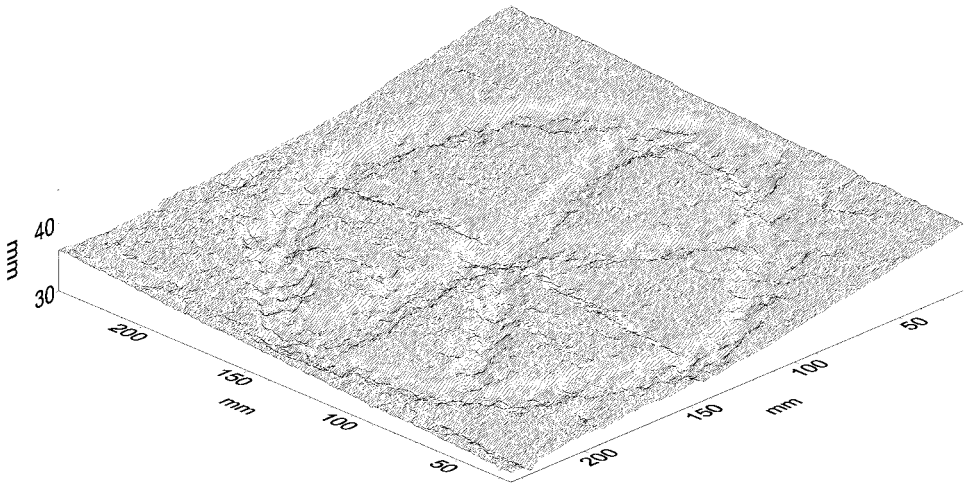
In contrast to the Hardeberga sandstone the Lingulide sandstone at Husaby 70, Flyhov (site 14) on the mesa hill Kinnekulle, is fairly soft and has a porosity of more than 10%. Calculated downwearing rates are also higher than at any of the other rock carving sites that were investigated. For the period between 1994 and 2003 results point to a rate of 60.83 mm in 1 000 years, but if only the period from 1996 to 2003 is considered the calculated downwearing rate falls to 2.46 mm in 1 000 years. The very high rate between 1994 and 2003 is difficult to explain. It might be erroneous and caused by variations in the

Fig. 7. 3-D model in orthographic projection of a well preserved circle-cross in Cambrian sandstone at Flyhov in the parish of Husaby, province of Västergötland (site 14). The vertical exaggeration is 2.5 times.

lichen growth on the rock during different measurement occasions since the lichens were difficult to remove completely. They are very firmly attached to the porous rock. It can, however, be considered that downwearing is fast and that it mostly proceeds by the loss of single sand grains when the support between them is lost. It is necessary to take precautions to expand the lifetime of this panel that was discovered in 1889. On an adjacent more recently cleaned part of the outcrop the rock carvings are still very well preserved since they have been covered by a thick enough layer of soil for a prolonged period. Glacial microforms shaped by the land-ice are also seen here. In figure 7 a circle-cross from this part is shown. Cut marks indicating how the figure was created are clearly visible.
