Weathering and decay

Breakdown rates of rock carvings in the southern part of Sweden

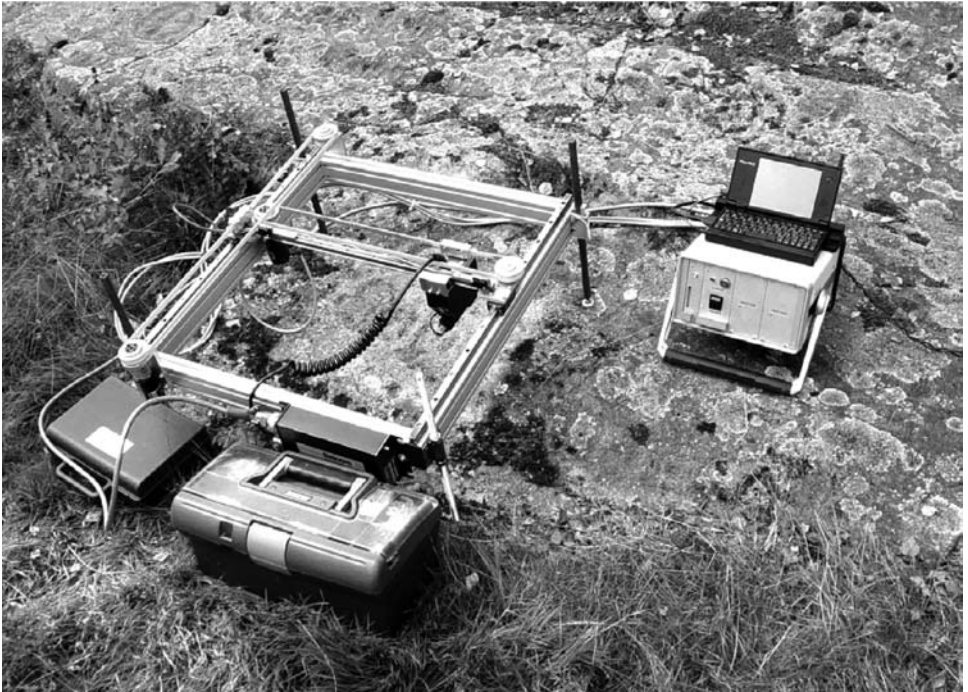
Fig. 2. The laser scanner during measurement at site 13 (Foss 6, Lökeberg) in the province of Bohuslän. There is a dense lichen growth on the veined gneiss. The two motor cycle batteries used as power source are not seen in the picture.

present mainly by granular disintegration although the rock types are contrasting. At Vårfrukyrka 192 the rock is of Svekofennian supracrustal origin and can be described as gneissic mica schist. The measurements were made over a number of cup marks (figure 5) and the calculated downwearing amounted to 12.98 mm in 1 000 years between 1994 and 1996. The result is somewhat inconclusive since it was difficult to get a good overlap between measurements from consecutive occasions, but it is clear that decay is fast. It could be that such features as cup marks are preserved for a long time even at places with rapid rock breakdown. There is a possibility that they weather, and deepen faster than the surrounding surfaces are lowered. If other rock carvings have ever been present at this site they would already have disappeared due to the intense weathering. The grey, veined gneiss at Foss 6, with a calculated downwearing rate of 3.73 mm in 1 000 years between 1996 and 2002, has a soft and porous surface and the lichen growth on the rock carvings is extensive. The figures on the panel are often cut to a depth of more than one cm but their contours are not very distinct due to the severe recent decay. When the character of the rock with its surface alteration is taken into consideration it can be expected that the lifetime of the rock carvings at Foss 6 is limited.
